| | | <u>Page</u> |
|---|---|---|
| 1.0 | CARRIZO CREEK NEAR CARRIZO SPRINGS, TEXAS | C-9-1 |

Arid West Water Quality Research Project Habitat Characterization Study
Carrizo Creek Near Carrizo Springs, Texas

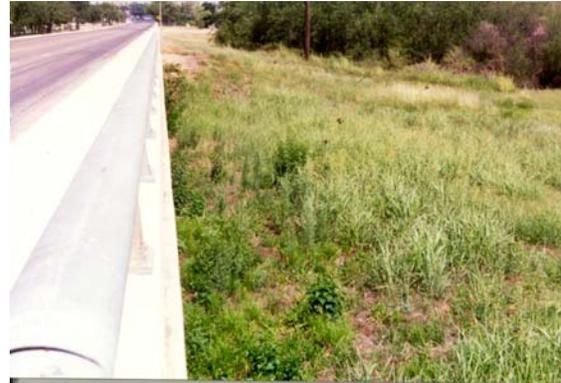
The Highway 85 bridge across Carrizo Creek upstream of the Carrizo Springs WWTP. The stream is not flowing at this location, which is about 0.4 mile upstream of the treatment plant outfall. Despite lack of flow, there were puddles in the stream channel at this location.

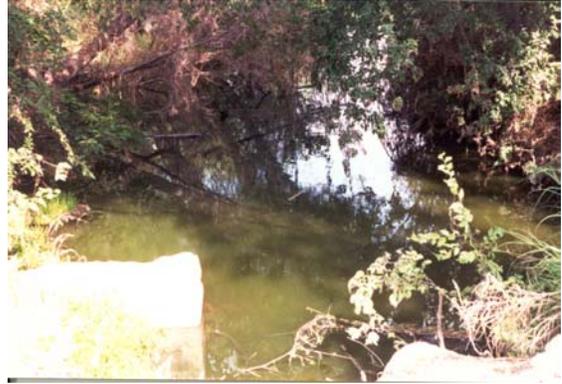
Terminus of a sewage pond that leads to the outfall culvert that discharges water into Carrizo Creek. Gar, bullfrogs, and an indigo snake were observed at this location.
